Fletcher's Home Inspections, LLC
806 Storm Mountain Court
Windsor,, Colorado, 80550

123 Dream Home Drive
Windsor, Colorado 80550

John Doe
123 Dream Home Drive

Table of Contents

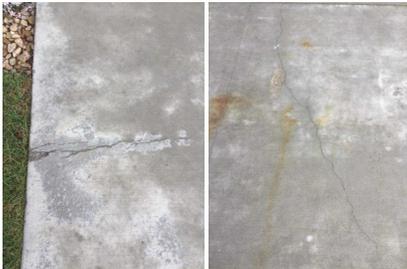
1. Driveway: Concrete- - Concrete pitted and cracked, this is not a reason to cause alarm but something any home owner should be aware of. If pitted and cracked area continues to grow, recommend further evaluation by a qualified contractor for replacement or repair.

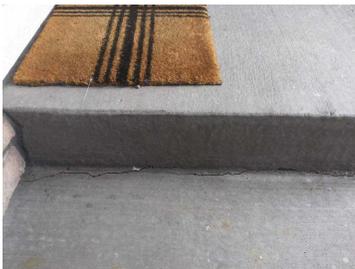
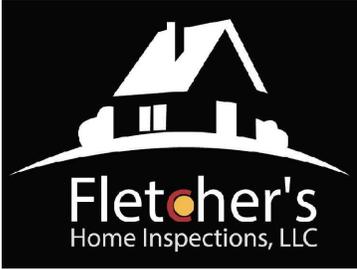
2. Walks: Concrete
3. Steps/Stoops: Concrete
4. Front Porch: Concrete- - Crack running along the entry step of front of house, this is not a reason to cause alarm but something any home owner should be aware of. If cracked area continues to grow, recommend further evaluation by a qualified contractor for replacement or repair.

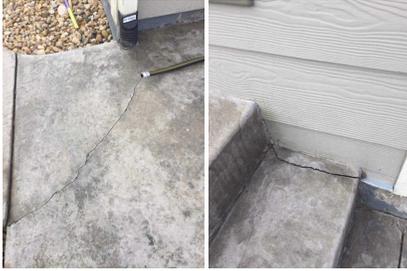
5. Patio: Concrete- - Concrete has cracks in couple different areas of the back patio, this is not a reason to cause alarm but something any home owner should be aware of. If cracked area continues to grow, recommend further evaluation by a qualified contractor for replacement or repair.

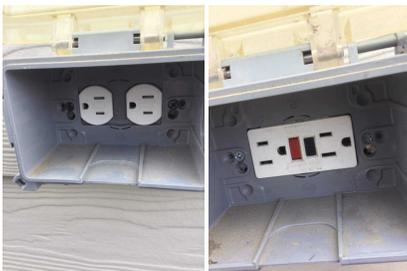
1. Type: Stone veneer
2. Trim: Plywood
3. Fascia: Plywood
4. Soffits: Plywood
5. Door Bell: Hard wired
6. Entry Doors: Metal
7. Patio Door: Metal sliding
8. Windows: Aluminum slider
9. Window Screens: Vinyl mesh
10. Basement Windows: Aluminum slider
11. Exterior Lighting: Surface mount
12. Exterior Electric Outlets: 110 VAC/ 110 VAC GFCI - Photo 1: Outlet on the west side of the home is not a GFCI outlet. All outlets on the exterior of a home are required to be a GFCI. Recommend further evaluation by a licensed electrician for replacement or repair.

Photo 2: Outlet on north side of house is a GFCI outlet but the test and reset buttons are non-operational. When testing outlet with a GFCI outlet tester, outlet failed to trip. Outlets that can be in direct contact with moisture must have a functioning GFCI to prevent electrical damage. Recommend further evaluation by a licensed electrician for replacement or repair.

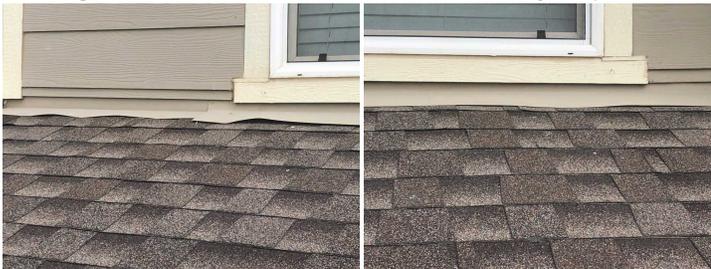
1. Method of Inspection: On roof
2. Material: Asphalt shingle
3. Type: Gable
4. Approximate Age: 2015
5. Flashing: Aluminum - - South facing side of house: 90 degree sidewall flashing has been installed as head wall flashing causing gaps that could allow wind-driven rain and may cause roof leak/water damage. Recommend further evaluation by a qualified contractor for replacement or repair.

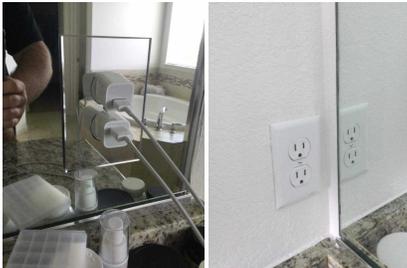
- 18. Electrical: 110 VAC - GFCI outlets must be in place on any receptacle within 6 feet of a water source. Recommend further evaluation by a licensed electrician for replacement or repair.

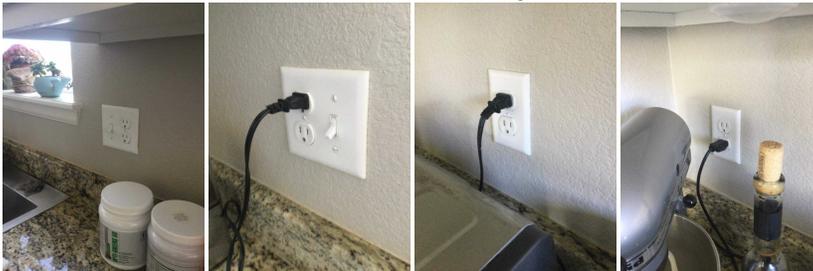
6. Refrigerator: Samsung
7. Microwave: General Electric
8. Sink: Stainless Steel
9. Electrical: 110 VAC - GFCI outlets must be in place on any receptacle within 6 feet of a water source. Recommend further evaluation by a licensed electrician for replacement or repair

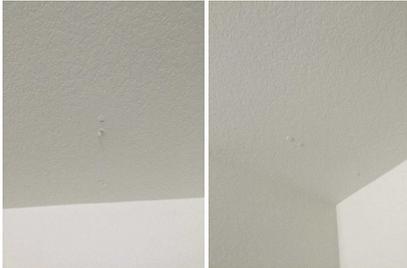
32. Ceiling: Paint- - Nails or screws coming loose and protruding through drywall. Recommend further evaluation by a qualified contractor for replacement or repair.

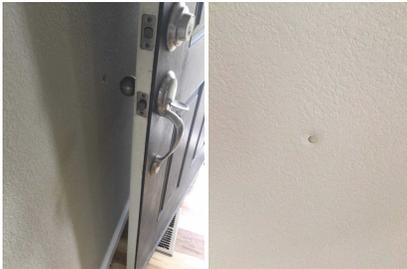
28. Doors: Front Door - Door does not have door stopper and drywall has become damaged. Issue may continue to worsen if not corrected. Recommend further evaluation by a qualified contractor for replacement or repair.

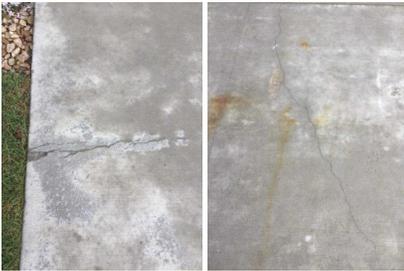
1. Driveway: Concrete- - Concrete pitted and cracked, this is not a reason to cause alarm but something any home owner should be aware of. If pitted and cracked area continues to grow, recommend further evaluation by a qualified contractor for replacement or repair.

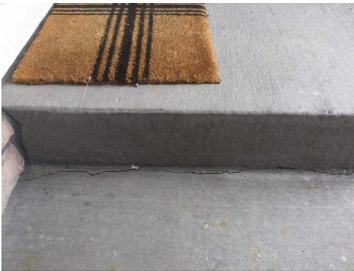
2. Front Porch: Concrete- - Crack running along the entry step of front of house, this is not a reason to cause alarm but something any home owner should be aware of. If cracked area continues to grow, recommend further evaluation by a qualified contractor for replacement or repair.

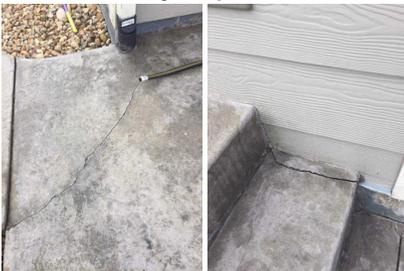
3. Patio: Concrete- - Concrete has cracks in couple different areas of the back patio, this is not a reason to cause alarm but something any home owner should be aware of. If cracked area continues to grow, recommend further evaluation by a qualified contractor for replacement or repair.

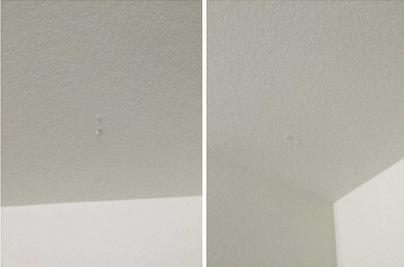
- 10. Master Bedroom Ceiling: Paint - Nails or screws coming loose and protruding through drywall. Recommend further evaluation by a qualified contractor for replacement or repair.

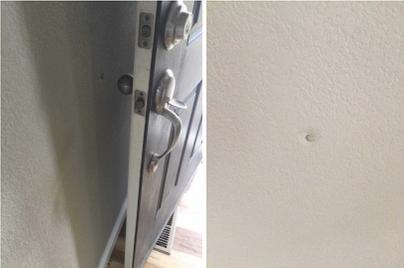
- 13. Great Room Living Space Doors: Front Door - Door does not have door stopper and drywall has become damaged. Issue may continue to worsen if not corrected. Recommend further evaluation by a qualified contractor for replacement or repair.

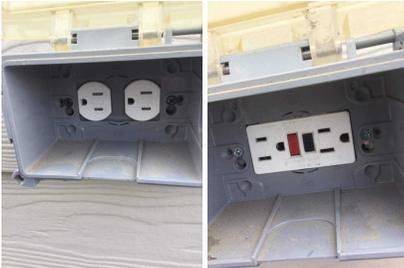
1. Exterior Electric Outlets: 110 VAC/ 110 VAC GFCI - Photo 1: Outlet on the west side of the home is not a GFCI outlet. All outlets on the exterior of a home are required to be a GFCI. Recommend further evaluation by a licensed electrician for replacement or repair.

Photo 2: Outlet on north side of house is a GFCI outlet but the test and reset buttons are non-operational. When testing outlet with a GFCI outlet tester, outlet failed to trip. Outlets that can be in direct contact with moisture must have a functioning GFCI to prevent electrical damage. Recommend further evaluation by a licensed electrician for replacement or repair.

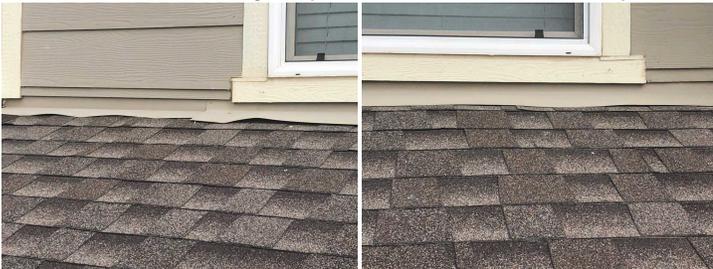
2. Flashing: Aluminum- - South facing side of house: 90 degree sidewall flashing has been installed as head wall flashing causing gaps that could allow wind-driven rain and may cause roof leak/water damage. Recommend further evaluation by a qualified contractor for replacement or repair.

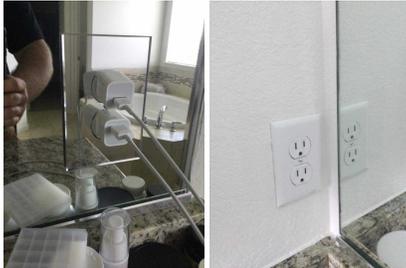
3. Master Bathroom Electrical: 110 VAC - GFCI outlets must be in place on any receptacle within 6 feet of a water source. Recommend further evaluation by a licensed electrician for replacement or repair.

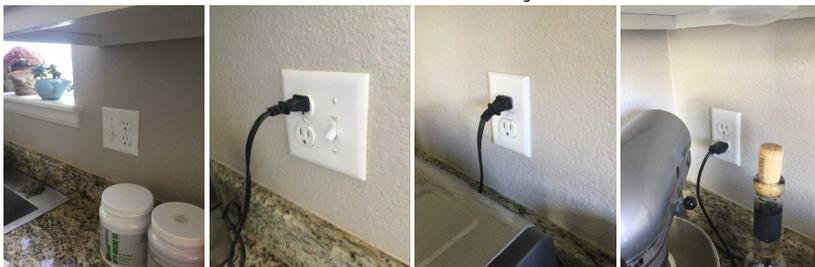
6. 1st Floor Kitchen Electrical: 110 VAC - GFCI outlets must be in place on any receptacle within 6 feet of a water source. Recommend further evaluation by a licensed electrician for replacement or repair

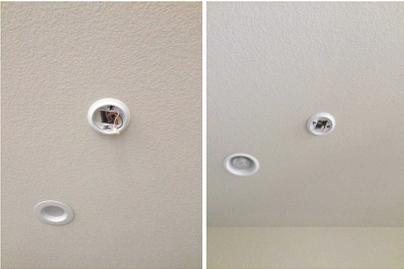
15. Study Living Space Smoke Detector: Hard wired- - not present at the time of inspection. Recommend further evaluation by a qualified contractor for replacement or repair.
